Is your Tri-chip LED Tube Not Working?

Some Tri-chip LED tubes were found not working even if they are connected correctly with each other. We noticed that a few batches of the LED tubes were accidentally wired in reverse polarity.

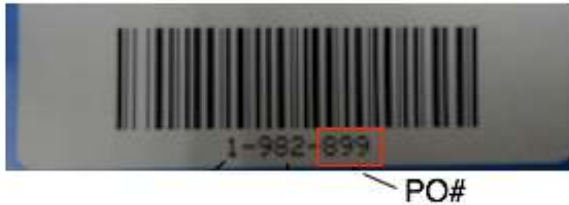
Product Label Barcode

Possible affected POs: PO 768, 785, 836, 860

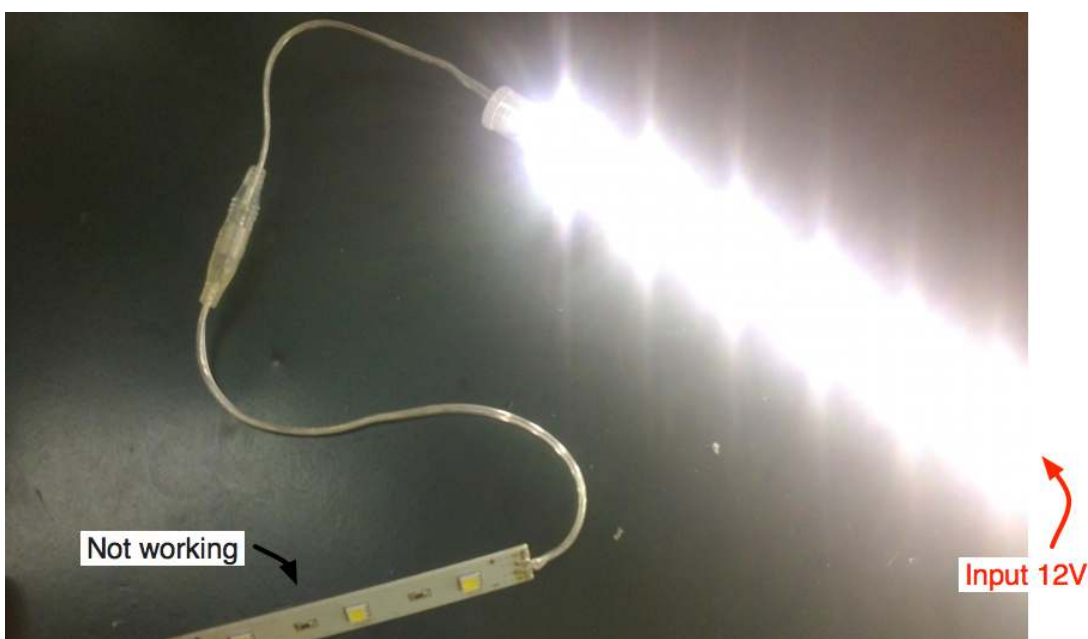
Affected versions:

- Both 9" and 20" tubes, but only White and Warm white.
